Bank Stabilization Implementation and
Assessment of the Connecticut River near
Colebrook and Groveton, New
Hampshire

Final Report

Connecticut River Joint Commissions
Charlestown, New Hampshire

Field Geology Services
Farmington, ME

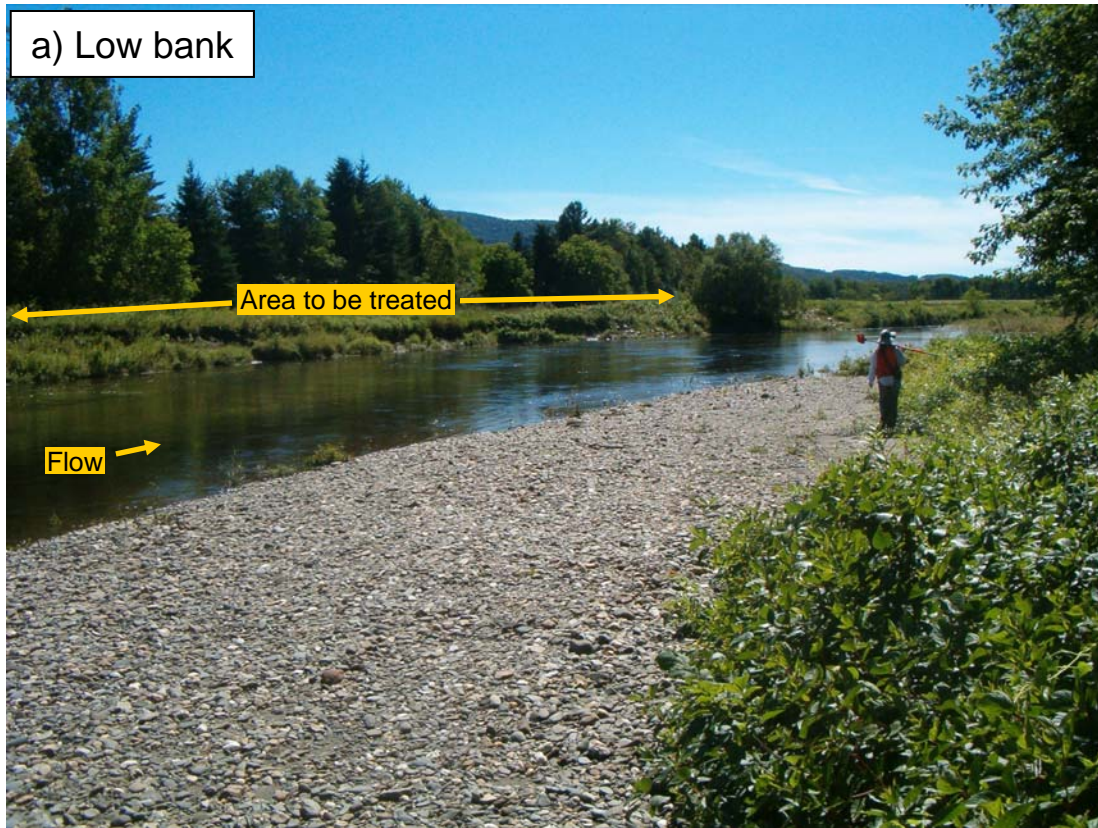
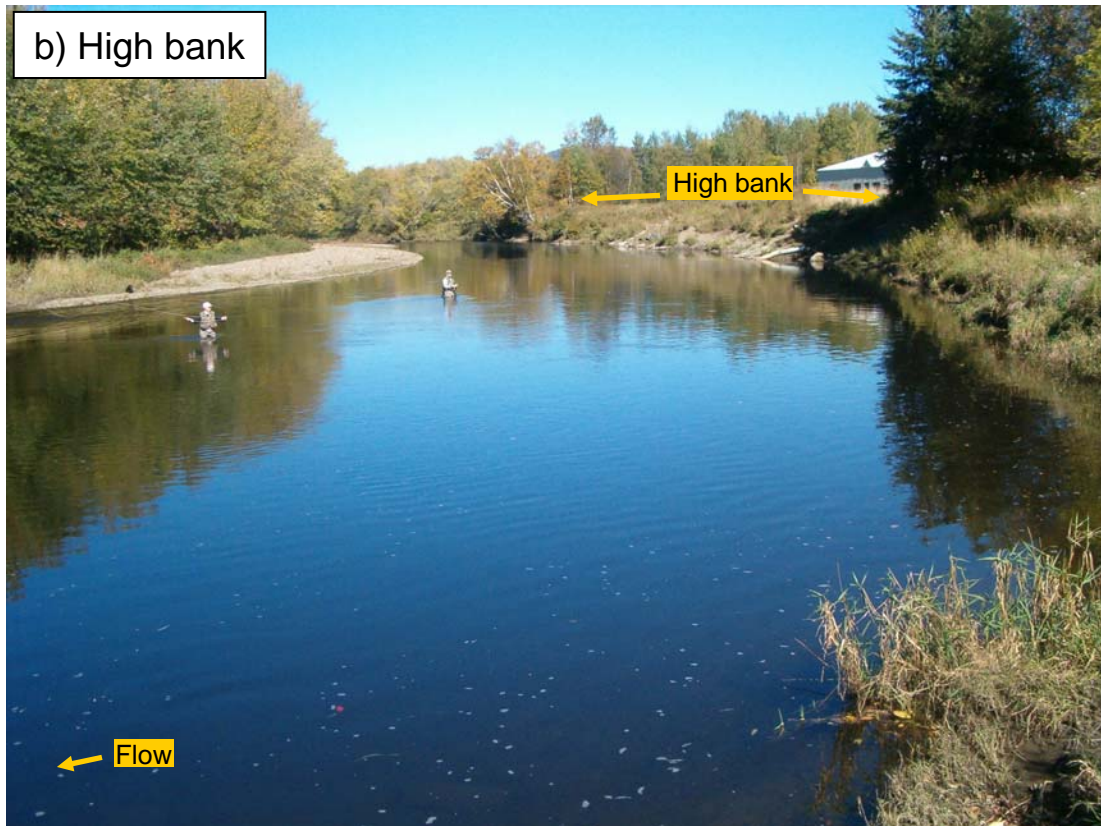
Bank Erosion at Colebrook Business Park

The severely eroding portion of the riverbank at the Colebrook Industrial Park is 730 feet long. The upstream 400 feet is a high bank (15 feet) composed of loose sands and gravels and the downstream 330 feet is a low bank (6 feet) of less erodible floodplain silt and clay (Figure 2). Design specifications were developed for a bioengineering project along the lower bank at the downstream end of the site (Appendix 3). The designs were submitted to the New Hampshire Department of Environmental Services and, as a result, a Standard Dredge and Fill Permit was secured by the Town of Colebrook in November 2005 that authorizes project construction (Appendix 4). Project construction will occur on the earliest practicable date in Spring 2006 when the fields are sufficiently dry and the river level low. The bioengineering project will stabilize the bank with the use of root wads placed along the bank. The bases of the tree trunks will be buried in trenches excavated perpendicular to the bank such that the root wads will protrude from the trench and protect the exposed soil from the river's flow (Appendix 3).

The roughness of the root wads will baffle flow and trap additional debris floating down the river, which will further protect the bank and create additional cover habitat at this popular fishing locale (Figure 2b).

Note: High bank is just upstream of low bank

Funds are currently being sought to extend the bioengineering project to the upstream end of the eroding bank at the Colebrook Business Park. Given the higher bank and greater erodibility of the bank sediments at the upstream end, an additional method for securing the root wads will need to be engineered before applying for a Standard Dredge and Fill Permit. Funds are also being sought to further analyze the feasibility of restoring flow to abandoned side channels on the lower Mohawk River. Spreading flow out into several flow paths on the lower Mohawk River will reduce sediment inputs to the Connecticut River, reduce the size of the gravel bars across from the eroding bank at the Colebrook Business Park, and slow the rate of erosion (Figure 3). The permitted bioengineering project and proposed extension to the high bank upstream are designed to provide short term protection against bank erosion as sustainable restoration efforts are assessed and implemented on the lower Mohawk River.

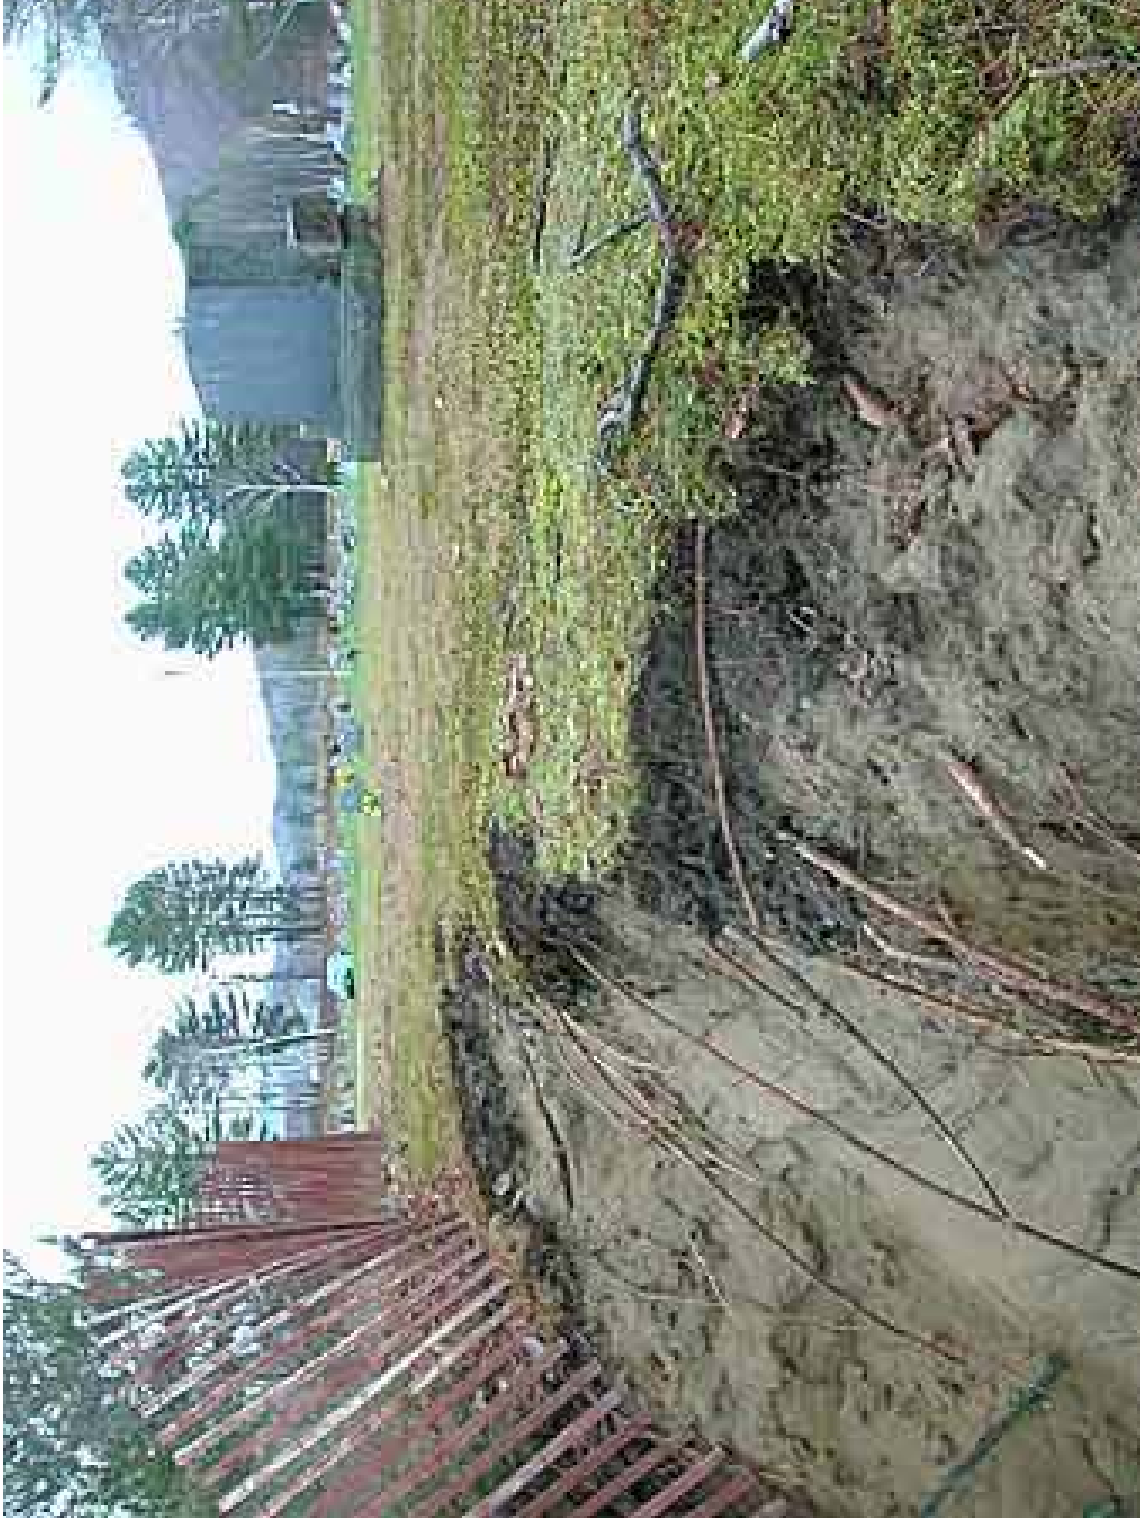
Erosion at the Northumberland Cemetery

Bank erosion at the Northumberland Cemetery is of great concern to the residents of Groveton and surrounding communities because of the impending likelihood that several graves will become exposed by further bank retreat (Figures 4 and 5). A report completed by the US Army Corps of Engineers in 2002 ranked erosion at the cemetery as a top priority for stabilization among several erosion sites along the northern Connecticut River (Army Corps, 2002). Interviews with local residents involved in cemetery operations indicate that erosion of the 35-foot high bank was first noticed in the early 1970's but accelerated in the 1980's. Since that time as much as 40 feet of bank recession has occurred along portions of the 400 feet of bank adjacent to the cemetery with a perimeter road closest to the bank lost as a result (Figure 6). While most of the erosion occurred prior to 2000, erosion continues to this day with more than 6 feet of bank recession occurring along a 15-foot portion of the bank in Fall 2005 (Figure 5).

Bank erosion at the cemetery occurs as discrete shallow rotational slumps (Figure 7). More recent slumps at times bisect older slumps such that over time the entire length of bank recedes. However, during a single slump failure only a portion of the bank fails (Figures 5 and 7). Over 5 feet of bank can be lost during a single slump but typically not along more than a 30 foot length of bank. The slump block itself remains intact as it moves away from and down the river bank. While vegetation generally remains standing, taller trees tend to lean in toward the bank as a result of the rotational slumping. Bare soil is often exposed along the scarp at the head of the slump failure (Figure 5).

Bank stratigraphy at the cemetery is characterized by buff-colored stratified glacial outwash sands overlying a gray thinly laminated silt and clay (Figure 8). The contact between the permeable sand above and more impermeable silt and clay below is at or near the water surface at low flow. As a result of this bank stratigraphy the banks are naturally susceptible to bank erosion with the shallow slumps consistent with the sandy nature of the soil (clay soils would lead to deeper slumps). Water percolating through the sand creates seeps at the base of the bank at the contact with the silt and clay below (Figure 8a). This lubricates the contact surface which serves as the basal plane of detachment along which the slump blocks rotate. Since the water surface is above the stratigraphic contact during peak flow when hydrostatic pressure favors the movement of groundwater into the bank (Figure 8b), the likelihood for bank failure is greater at the receding end of high flows when the groundwater flow direction is reversed. This was the case for recent bank failures (Figure 5) and is consistent with observations by local residents.

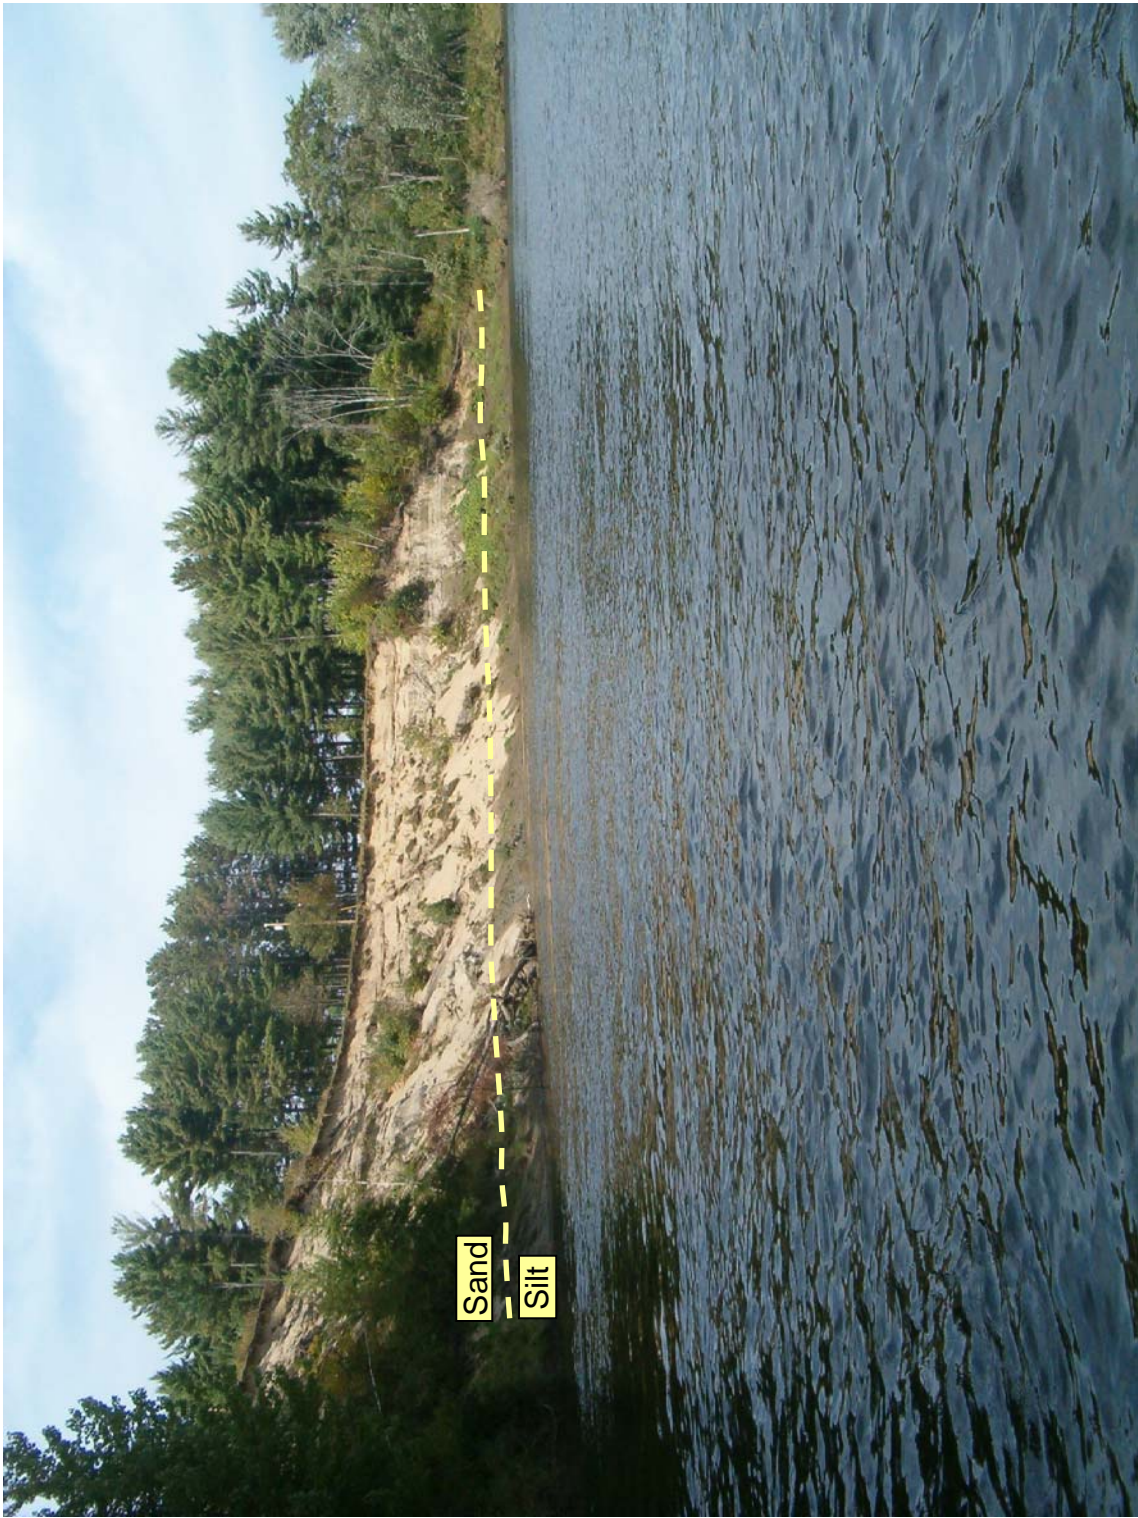
Eroding Bank Upstream of the Old Wyoming Dam

A similar stratigraphy is exposed along nonalluvial banks throughout the reach between the Upper Ammonoosuc River confluence and the Old Wyoming Dam. Even more dramatic erosion is observed elsewhere in the reach but these locales are a lower restoration priority, because of minimal threats to human structures and investments

(Figure 9). Shallower slip failures than observed at the cemetery extend continuously for over 100 feet in certain locations, but otherwise the mode of bank failure throughout the reach is similar to conditions at the cemetery.

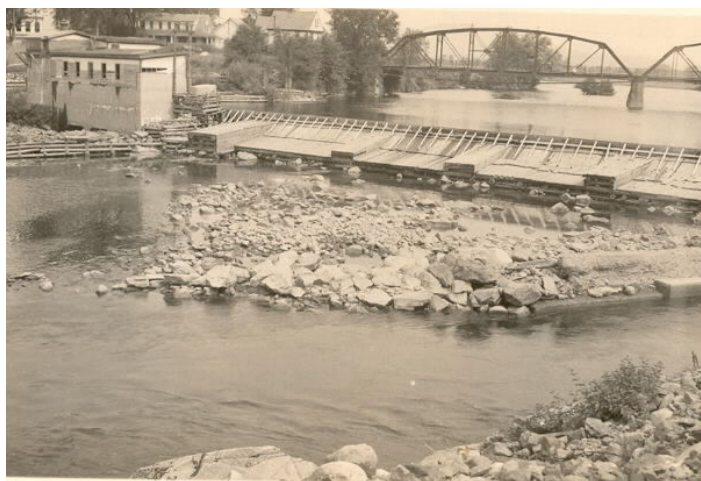
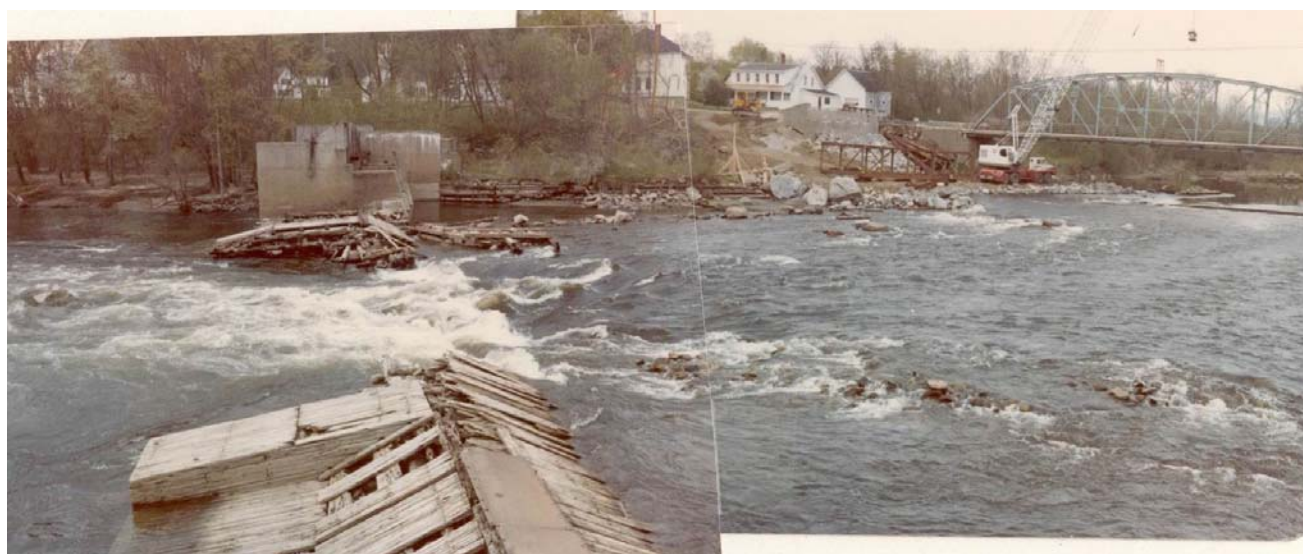
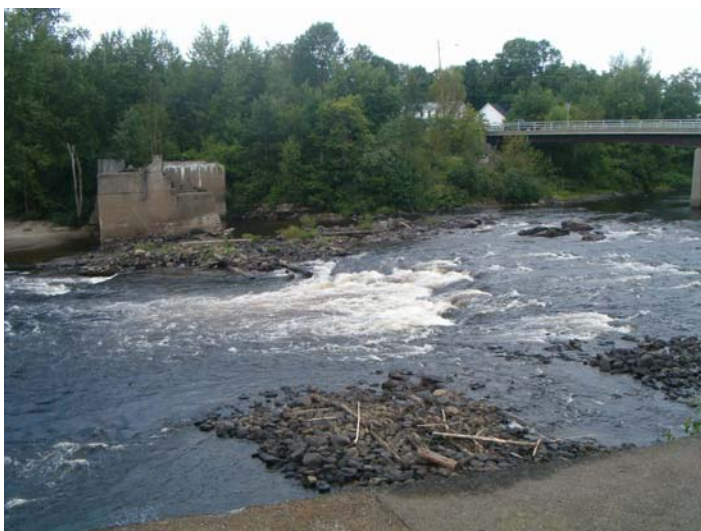
Changing Condition of the Old Wyoming Dam

The topographic survey data were further utilized to complete HEC-RAS hydraulic modeling of the 3.3 mile reach between the Upper Ammonoosuc confluence and Old Wyoming Dam (Appendix 6). A number of dams have been located at the site of the Old Wyoming Dam since the 1700's with the latest rebuilt in 1936 (Figure 13a). By the mid-1980's the dam had been breached (Figure 13b) and only the abutments at the margins of the channel remain today (Figure 13c). Water levels at the dam were several feet higher than today when the dam was in place (Figure 13). The HEC-RAS modeling was completed by Woodlot Alternatives of Topsham, ME and was used to determine how water levels and water surface gradients changed upstream, including at the cemetery, when the Old Wyoming Dam was breached in the 1980's.

The acceleration of erosion at the cemetery in the mid-1980's began at approximately the same time the Old Wyoming Dam was breached. Dam removal, and the accompanying increases in water surface slope and flow velocities, could have generated channel incision. Lowering of the channel bed through incision would lead to the bank slumping observed throughout the modeled reach, including the cemetery. The high steep banks that are naturally susceptible to erosion would fail and collapse when undermined. Continued active erosion throughout the project reach suggests that the channel is still responding to the dam breach over 20 years ago.

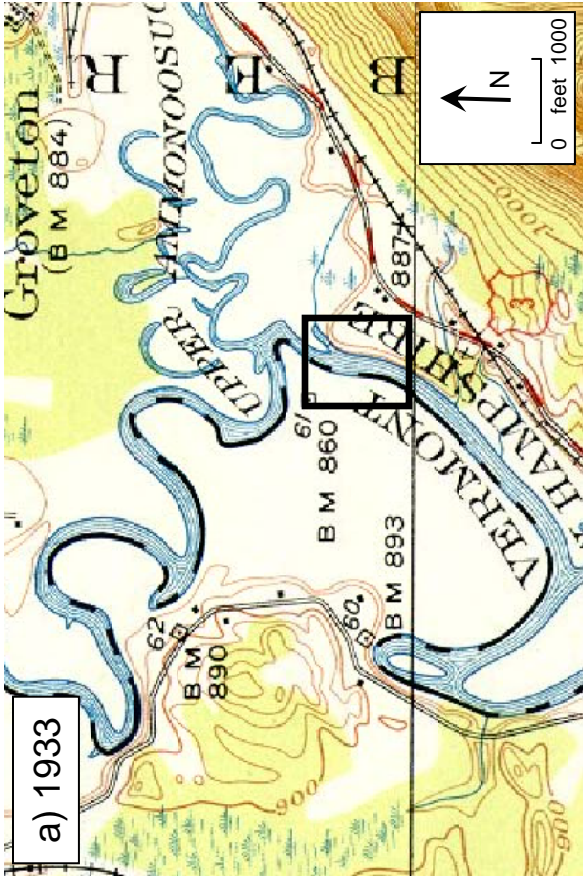
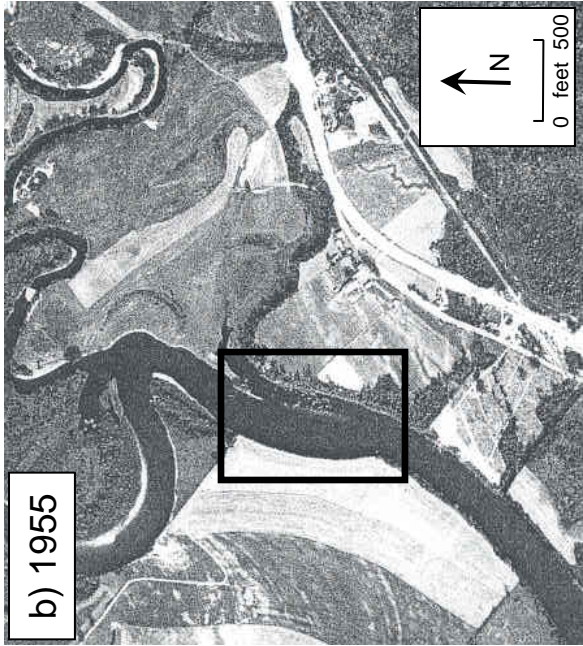
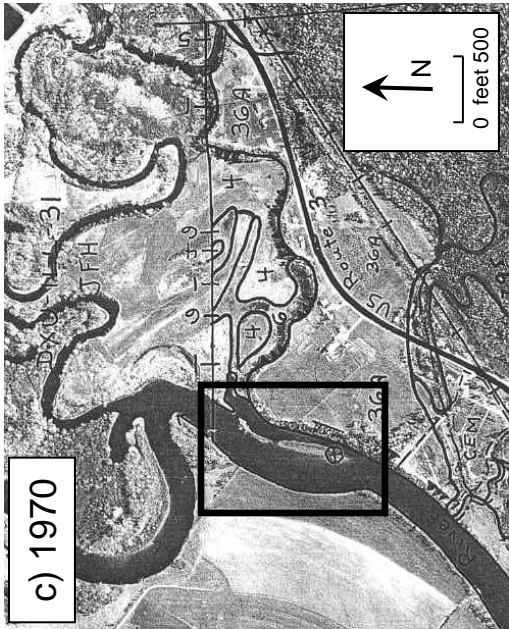
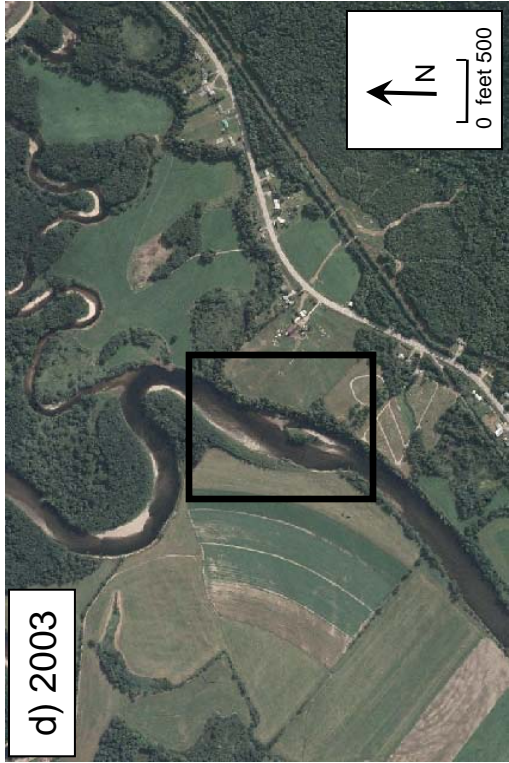
Changes to Sandbar Upstream of the Northumberland Cemetery

While no major changes in channel position were observed on historical topographic maps and aerial photographs, the emergence of and changes to the sand bar immediately upstream of the cemetery are evident (Figure 15). No sand bar was present immediately upstream of the cemetery in 1933 (Figure 15a). Given that sand bars are shown on the 1933 topographic maps in many other locations on the northern Connecticut River, a bar likely would have been shown if present near the cemetery. By 1955 a small sand bar is present at the site (Figure 15b), which became much larger by 1970 (Figure 15c). The river discharge at the stream gauge in Dalton, NH downstream of

the site was 640 ft³/sec on the date of the 1955 aerial photograph (July 20th) and 2,640 ft³/sec on the date of the 1970 aerial photograph (October 19th). Consequently, the difference in sand bar size is not the result of variations in water surface elevation; for the same discharge as the 1955 aerial photograph, the sand bar on the 1970 aerial photograph would have appeared even larger. The upstream end of the bar in 1970 is located at and bends toward the mouth of a small side channel of the Upper Ammonoosuc River. Since 1970, the sand bar has diminished in size from the upstream end and a portion of the bar has become vegetated (Figures 15d and 16). The 2003 aerial photograph was taken in September when river discharge for the entire month was lower than on the date of the 1970 photograph such that the smaller size of the bar is not the consequence of a higher river level.

The pattern and timing of sand bar growth suggests the side channel of the Upper Ammonoosuc River is, at least in part, the source of sediment for the bar. The side channel is active only during large flow events and the first evidence of the bar in 1955 may be related to sand deposited at the mouth of the side channel during the large 1936 flood. Another large flood in 1969 related to the breaching of the Nash Stream Bog Dam in the Upper Ammonoosuc watershed likely reactivated the side channel and enlarged the bar as observed on the 1970 aerial photograph. [The impacts of the 1969 event on the Upper Ammonoosuc are discussed further in the tributaries report]. The reforestation of the side channel since 1970 (compare Figures 15c and 15d) is consistent with the absence of large floods on the Upper Ammonnosuc River. Without sediment supplied from the side channel, low to moderate flows on the Connecticut River have slowly eroded the upstream end of the bar for the past 35 years.

The assessment steps described above enable a critical analysis of the causes for erosion at the cemetery. Sediment inputs from tributaries were identified as a significant cause for erosion on the northern Connecticut River during the 2004 fluvial geomorphology assessment (Field, 2004). Sand and gravel bars forming at the mouths of tributaries cause the flow to be deflected into the opposite bank where erosion occurs. The sand bar just upstream of the cemetery is causing flow to be deflected into the bank on the west (Vermont) side of the river and the resulting erosion has caused a slight bend in the river (Figures 16 and 17). Flow diverted around the bar in the opposite direction runs along the base of the eastern bank and may be responsible for erosion at the cemetery. The erosion may be enhanced as flow returning to a single channel at the downstream end of the bar is aimed directly at the cemetery bank (Figure 16). Given the high bank, bank recession due to erosion on the eastern side of the river would not be as pronounced as on the western bank. The start of the erosion in the 1970's coincides with the maximum size of the sand bar when flow deflection around the bar would have been the most severe. The acceleration of erosion in the 1980's, however, would not be expected as the bar diminished in size, so additional causes must be responsible for the cemetery erosion.

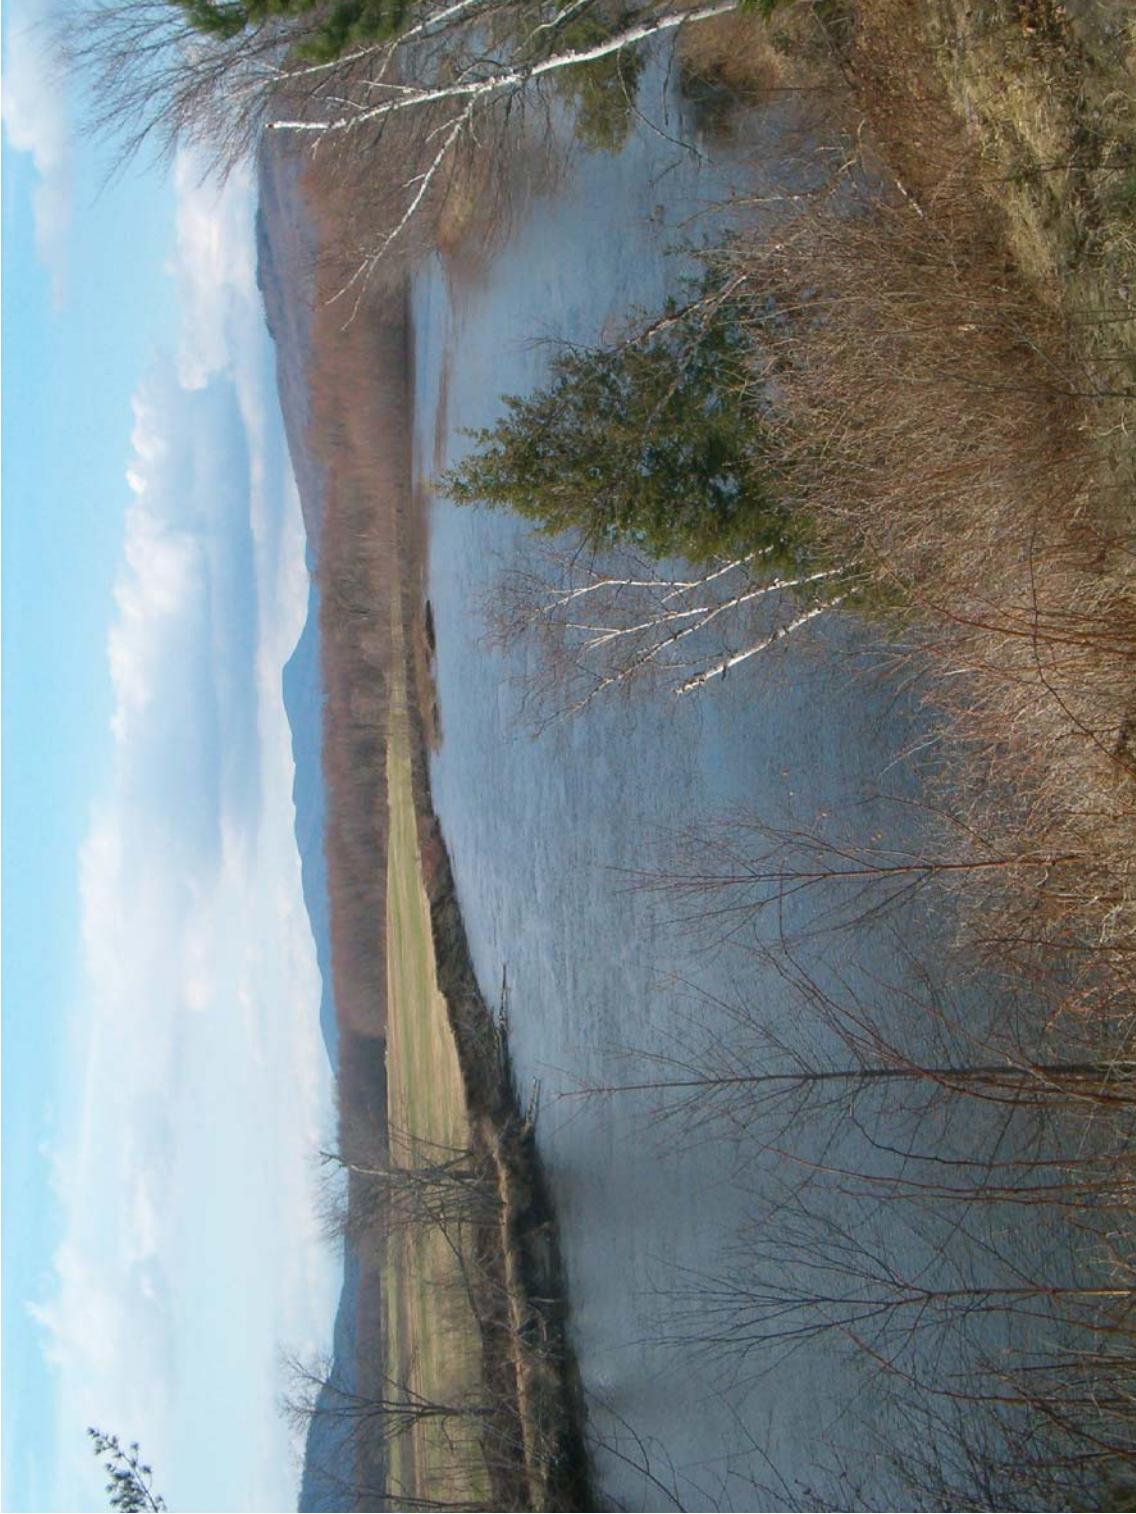
Erosion on Vermont Side of River Opposite the Cemetery

Note: Photograph taken from top of bank at cemetery with sand bar at center right of photo

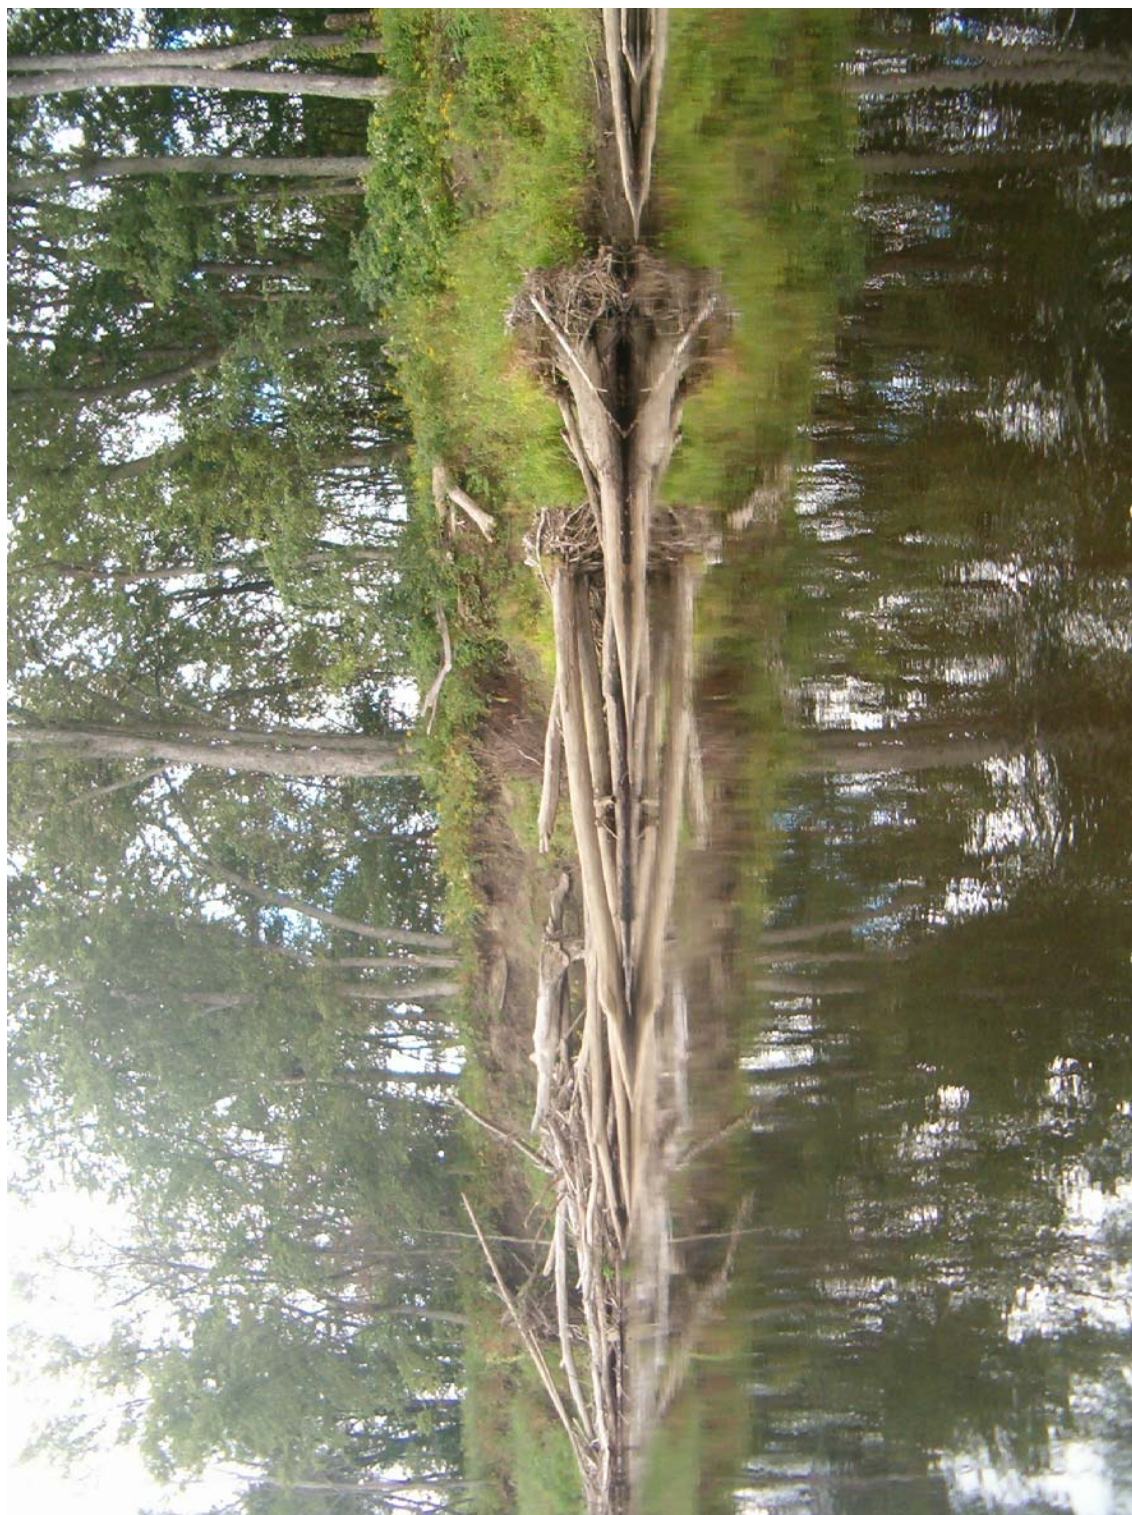
Naturally Occurring Log Jam on the Connecticut River

Note: Located just upstream of the Upper Ammonoosuc River confluence

The favored option for managing the site is to combine the planting of trees with the construction of an engineered log jam. Log jams naturally form on the Connecticut River (Figure 18) and a mass of logs at the base of the slope should buttress the bank against future slumping. Slumps that do occur will be held back behind the logs, decreasing the slope angle and reducing the likelihood of additional slumps. If channel incision continues, the logs may settle downward but should continue to provide bank support. The log jam will decompose over a period of 10 to 30 years while the planted trees have had time to mature and sustain the bank stability initiated by the bioengineered structures. In addition to providing bank stability, the engineered log jams will provide cover habitat for fish and a substrate for aquatic insect colonization. Maturing trees on the slope will also improve habitat by shading the river and providing cover as mature and dying trees fall into the river.

The primary difficulty in constructing an engineered log jam will be anchoring the logs to the bank. Unsecured logs will have a tendency to float downstream during a high flow with the potential for damage at the Northumberland-Guildhall Bridge. Funds are being sought to complete a detailed engineering analysis that will consider multiple options for securing the logs to the bank including: cabling the logs to large rocks placed on or buried below the channel bed; attaching the logs to metal sheet piling driven into the base of the bank; cabling the logs to log pilings driven vertically into the channel bed; or tying the logs off to large trees on the slope or at the top of the bank. The cost and structural stability of each option will be compared in order to achieve project goals at minimum cost.
