# Bank Stability and Composition on the Connecticut River in central Pittsburg, NH.

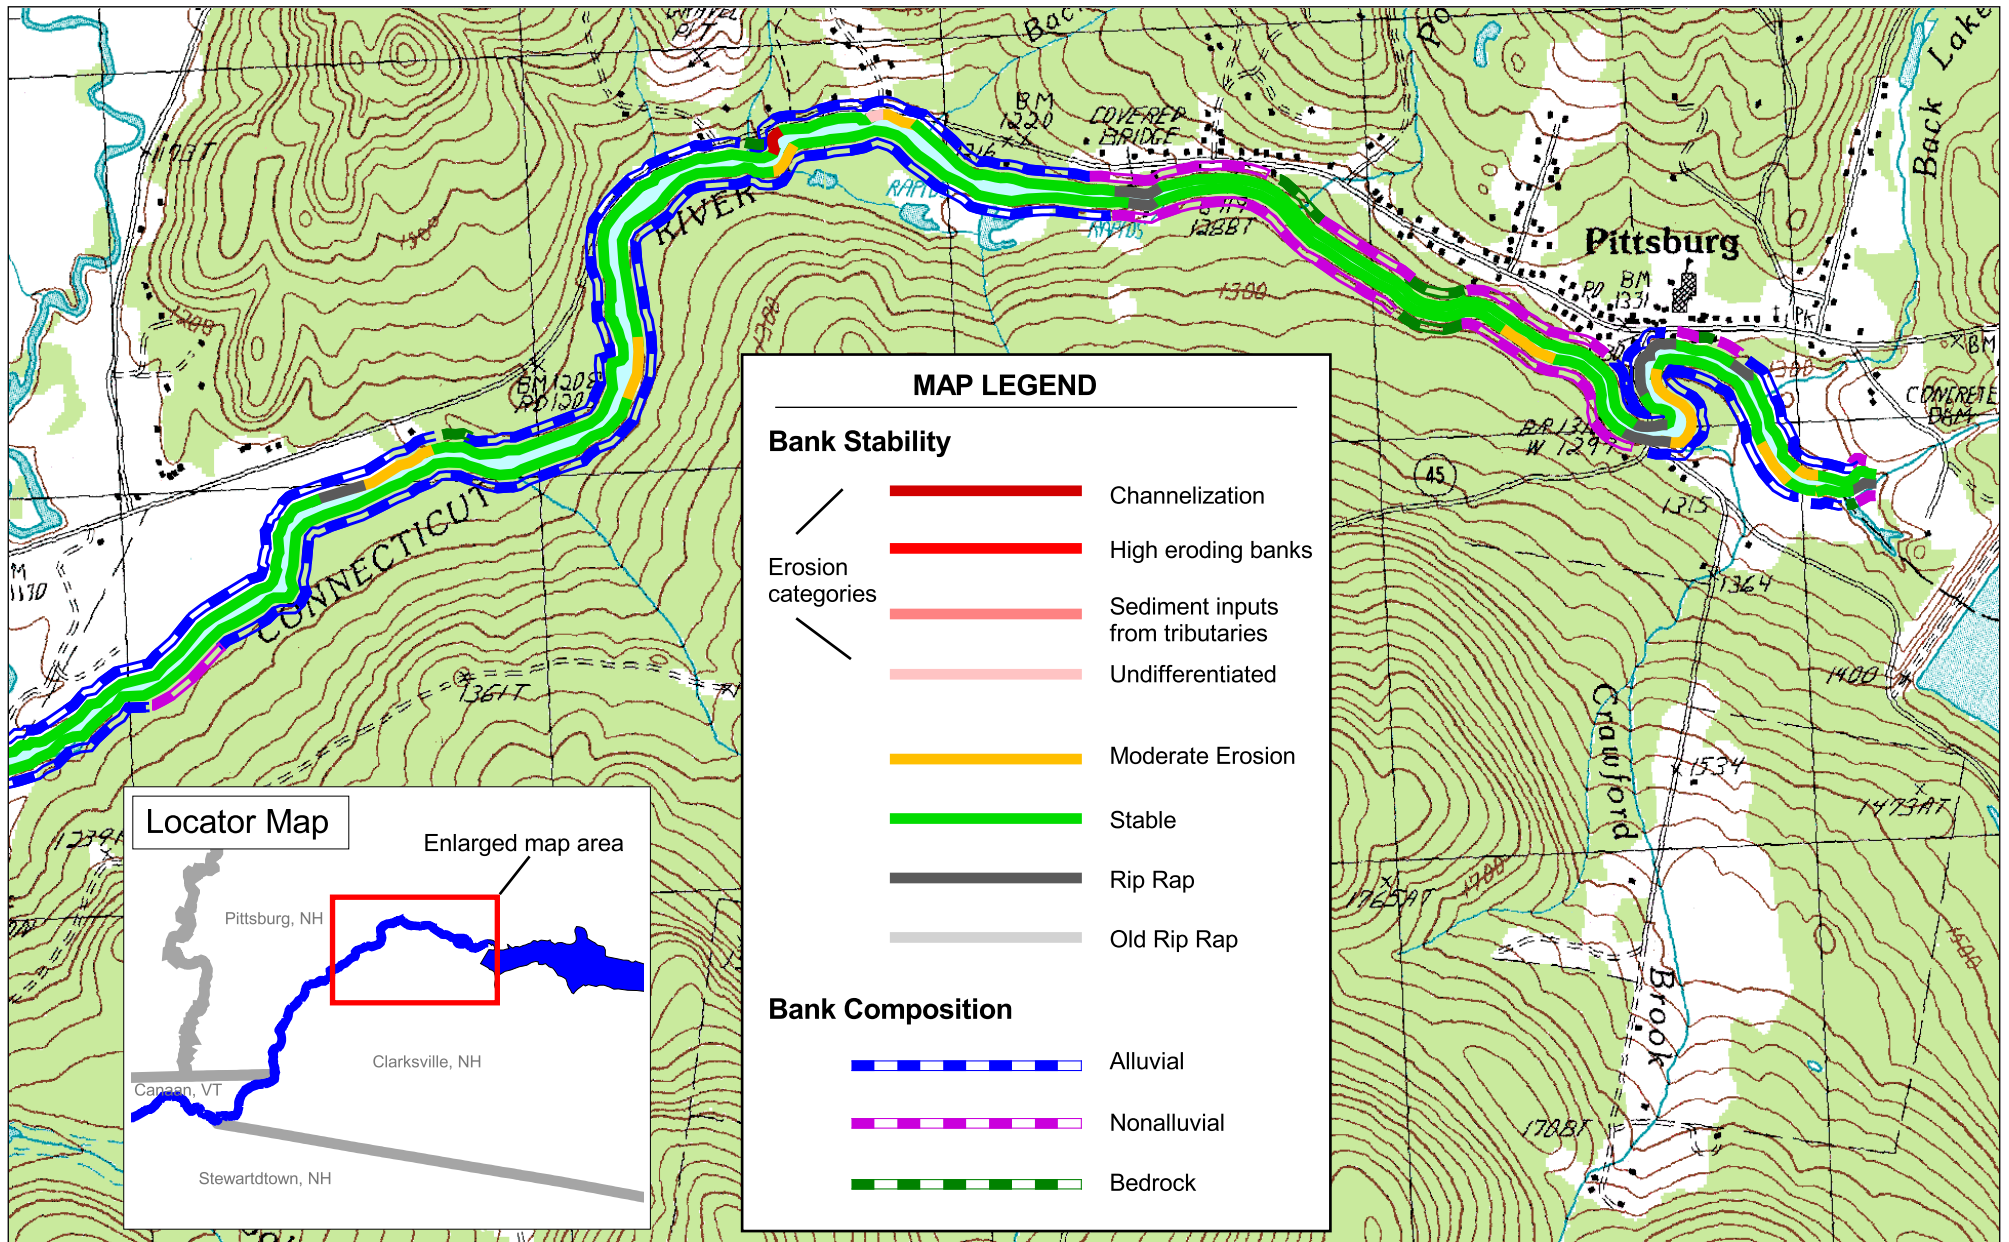
**Bank Stability**

- Channelization
- High eroding banks
- Sediment inputs from tributaries
- Undifferentiated
- Moderate Erosion
- Stable
- Rip Rap
- Old Rip Rap

**Bank Composition**

- Alluvial
- Nonalluvial
- Bedrock
