Bank Erosion on the Upper Connecticut River

Causes & Management of Bank Erosion on the Upper Connecticut River

Understanding the causes of erosion can lead to long-term solutions to persistent problems

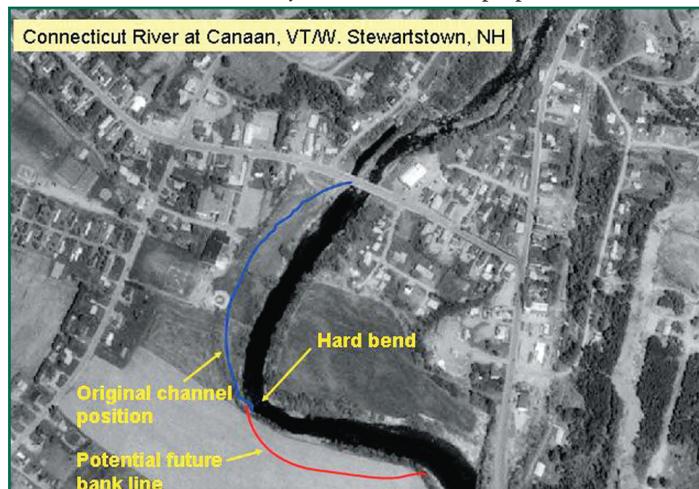
Channelization

Over 30 percent of the northern Connecticut River was straightened by humans in the 19th century. Reasons for this straightening likely include log drives, railroad construction, and agriculture. While bank erosion previously occurred in the straightened areas as the channel widened, erosion continues today primarily where the straightened channels re-enter naturally meandering sections at artificially sharp bends. The erosion will likely continue for decades but will diminish over time as the river spends its energy more evenly throughout the bend rather than focusing it at a single point.

- **Recreate the Natural Meander Pattern.** Returning the river to its original meandering channel would eliminate hard bends in the river, reduce erosive pressures, and diminish downstream sedimentation impacts. Current land use makes this option impossible in most situations but opportunities should be sought where this option can be used when land use changes.

- **Riparian Buffer Plantings.** Planting trees where erosion is occurring will reduce the rate of erosion as the trees mature. A reduced rate of erosion will minimize downstream impacts while enabling the channel to reach a stable configuration with more gentle bends. Federal programs are available to establish conservation easements and compensate landowners for lost agricultural productivity in planted areas.

- **Rock Riprap.** Placement of large rocks on the river bank will stop erosion at the site temporarily. However, this option should be employed only when roads or other human infrastructure are under immediate threat because stopping erosion at hard bends will lock the river in an unstable condition and transfer erosion downstream. Long-term success of this option is low, as erosive pressures will remain and eventually undermine the riprap.

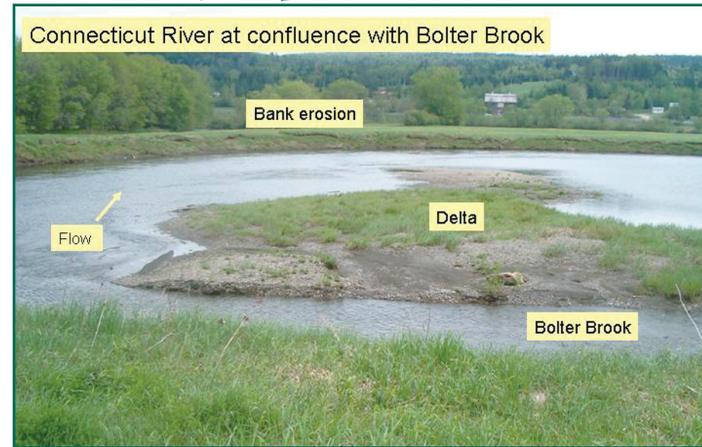
Tributary Inputs

Small deltas form at the mouths of tributaries as they enter the Connecticut River and deposit their sediment. Flow diverted around these deposits causes erosion as it is deflected into the opposite bank. Point bars and mid-channel bars often form downstream of larger confluences and erosion results from flow diverted around them. While some erosion probably occurred naturally at tributary confluences, human activities within the tributary watersheds, such as extensive land clearance or channel straightening, speed up the delivery of sediment to the mainstem and make the erosion problems worse.

- **Reduce Sediment Inputs.** If the amount of sediment entering the mainstem is reduced, the sand and gravel bars will diminish in size, cutting down the rate of erosion. Sediment inputs could be reduced by either stabilizing sediment sources or storing sediment in the tributary watershed. This option may require watershed-scale restoration and could take years before improvements are seen. May work best in smaller tributary watersheds.

- **Bioengineering.** The use of logs to deflect water away from the eroding bank will reduce erosion while improving fish habitat. The deflected flow could scour the bar at the tributary confluence and reduce flow impacting the eroding bank. If sediment inputs remain high, however, sediment may be transferred further downstream, creating new erosion problems. Buffer plantings are also advised.

- **Rock Riprap.** Placement of large rocks on the river bank will stop erosion at the site temporarily. However, as sediment continues to build out into the channel, the lack of erosion on the opposite bank will result in a narrowing of the channel and scour at the base of the riprap. If riprap is not built below the channel bed, the rock could be undermined.

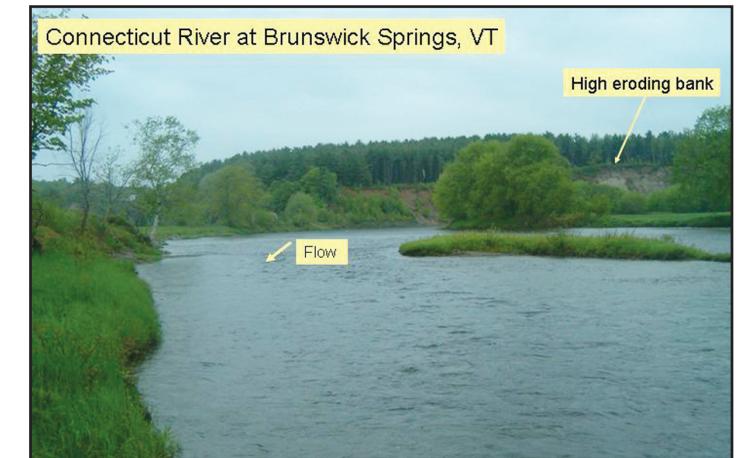
High Eroding Banks

Sediment eroding from high banks of glacial outwash deposits may create a greater load of sediment in the river than it can carry. Therefore, sand and gravel bars form downstream of the high banks. Flow diverted around the bars leads to erosion of the adjacent banks much like at tributary confluences. Erosion of high banks may supply sediment several miles downstream, accelerating bar growth and aggravating erosion problems. The location of erosion can shift over time as bars migrate downstream.

- **Realignment of River Channel.** Moving the river channel away from the high bank and placing it elsewhere on the floodplain would eliminate the sediment inputs from the high bank. This option would work best where channel straightening is responsible for instability of the high bank and the channel can be returned to its original location. Current land use may make this option impossible but opportunities should be sought to use this option as the use of the land changes.

- **Riparian Buffer Plantings.** Planting trees where erosion is occurring will reduce erosion rates as the trees mature. Although flow deflection around bars will undermine the bank, the trees that fall in will provide further bank protection. Plantings should extend beyond the immediate area of erosion since the bars migrate downstream over time.

- **Rock Riprap.** Placement of large rocks on the river bank will stop erosion at the site. However, as bars migrate downstream, the focus of erosion will shift to unprotected areas along the river bank. This option should be employed only when roads or other human infrastructure are under immediate threat, because erosive pressures are unlikely to persist in a single area for long periods of time while the rock will remain indefinitely and affect channel stability downstream.

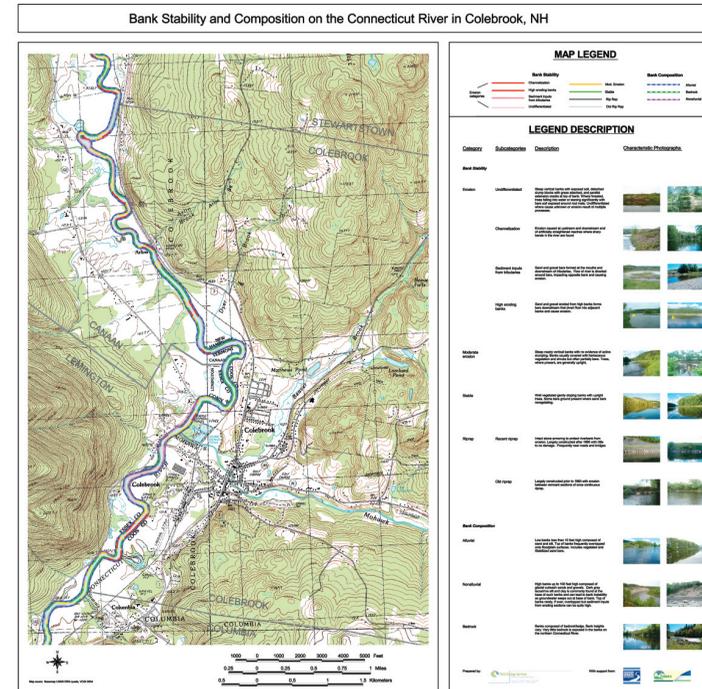
This brochure is intended to accompany maps of bank erosion and composition prepared for each town along the Upper Connecticut River. Please contact your town office for a copy of the erosion map of your town, or visit www.crjc.org. (Colebrook is shown below.)
