Bank Stabilization Implementation and
Assessment of the Connecticut River near
Colebrook and Groveton, New
Hampshire

Final Report

Connecticut River Joint Commissions
Charlestown, New Hampshire

Field Geology Services
Farmington, ME

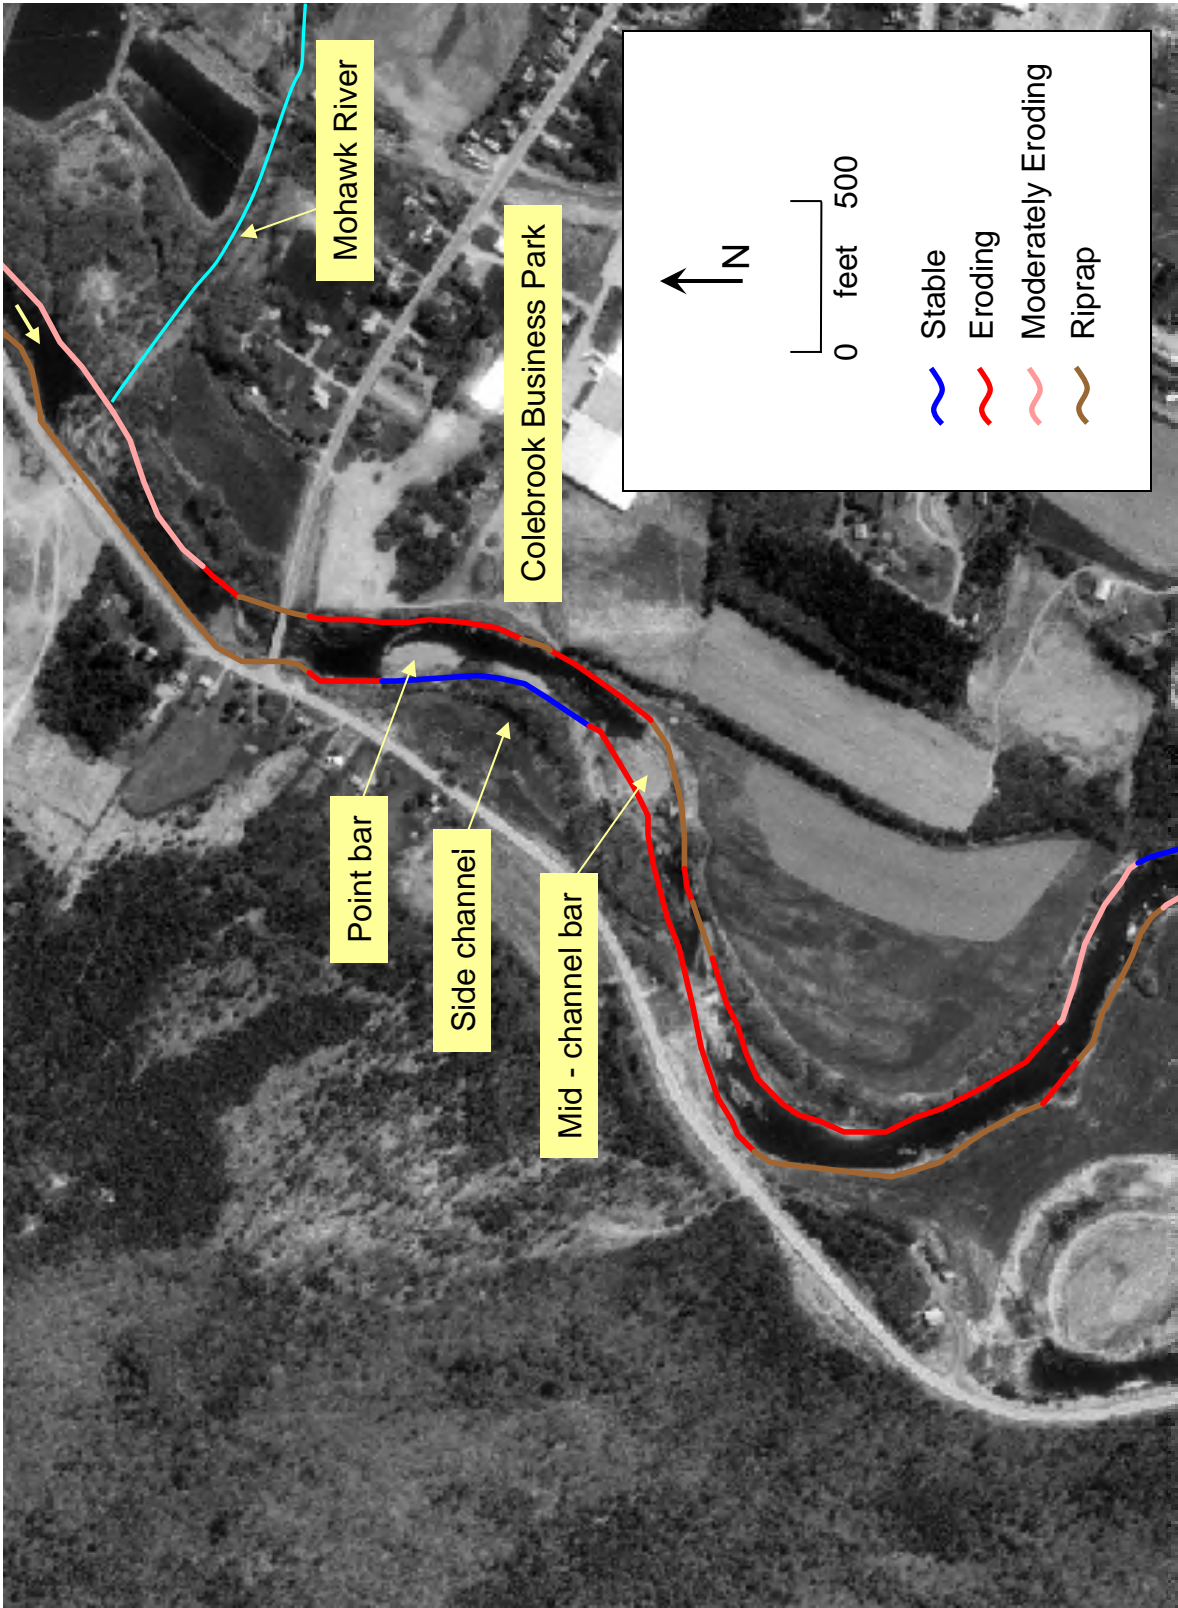
Relationship of Colebrook Business Park to the Mohawk River

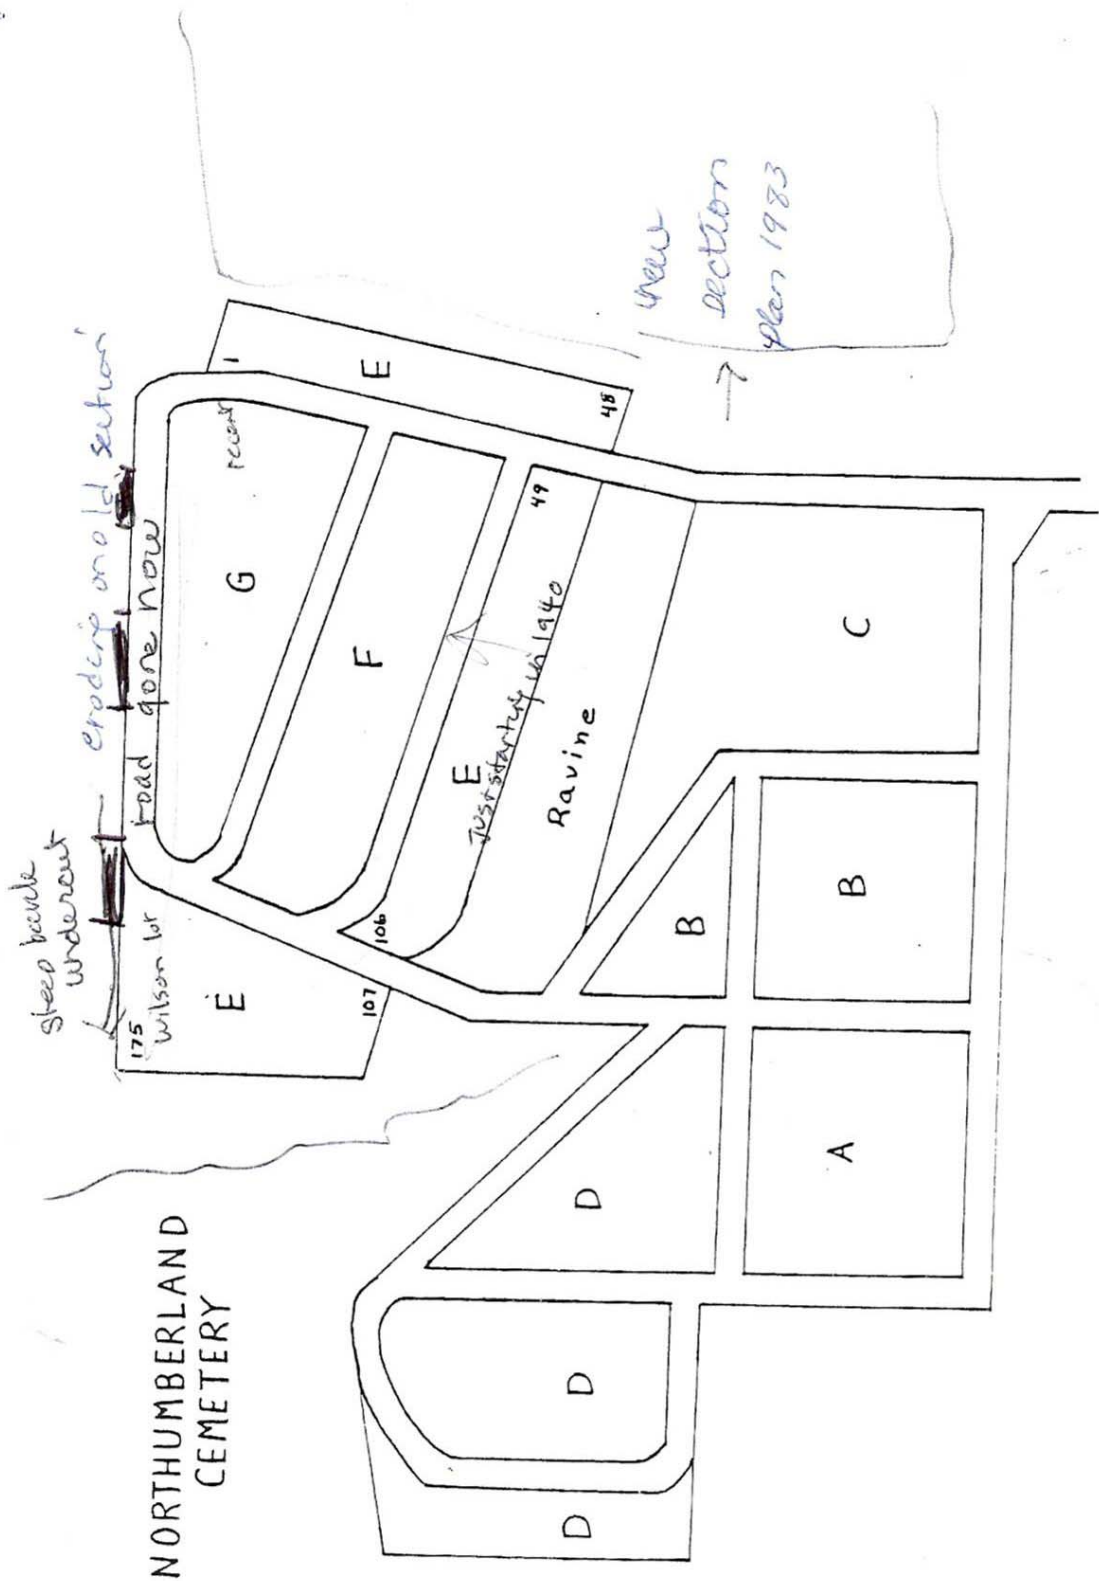
Map of Northumberland Cemetery

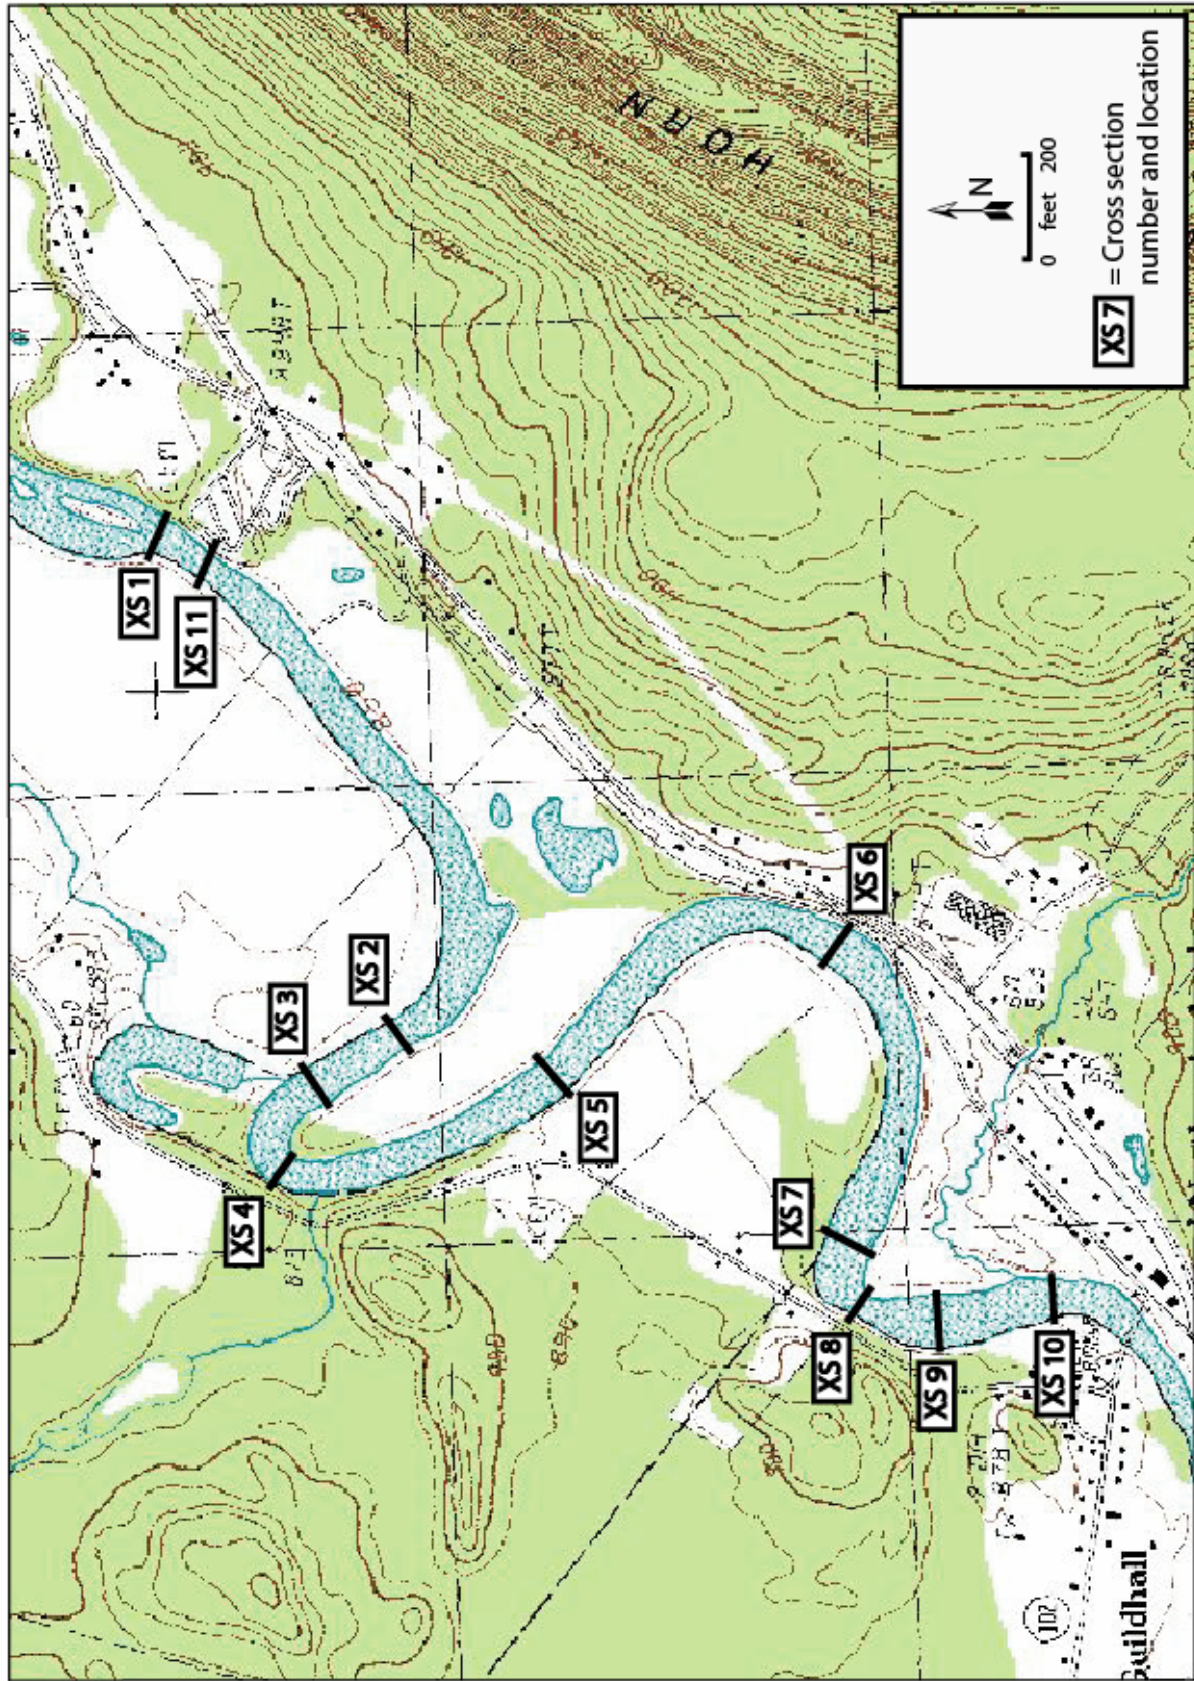
Bank Stabilization Implementation and Assessment - Figure 10

A longitudinal profile and 10 cross sections were surveyed between the Upper Ammonoosuc confluence and Old Wyoming Dam using a Sokkia Set 5 Electronic Total Station and Hondex Digital Depth Sounder (Appendix 5). The cross sections are located at various places along the reach but are not equally spaced (Figure 10). An eleventh cross section was surveyed at the base of the cemetery during Phase 2 of the 2004 fluvial geomorphology assessment. The longitudinal profile recorded the elevation of the water surface and thalweg (i.e., deepest part of the channel) from the upstream to downstream end of the reach.

Location of Connecticut River Cross Sections

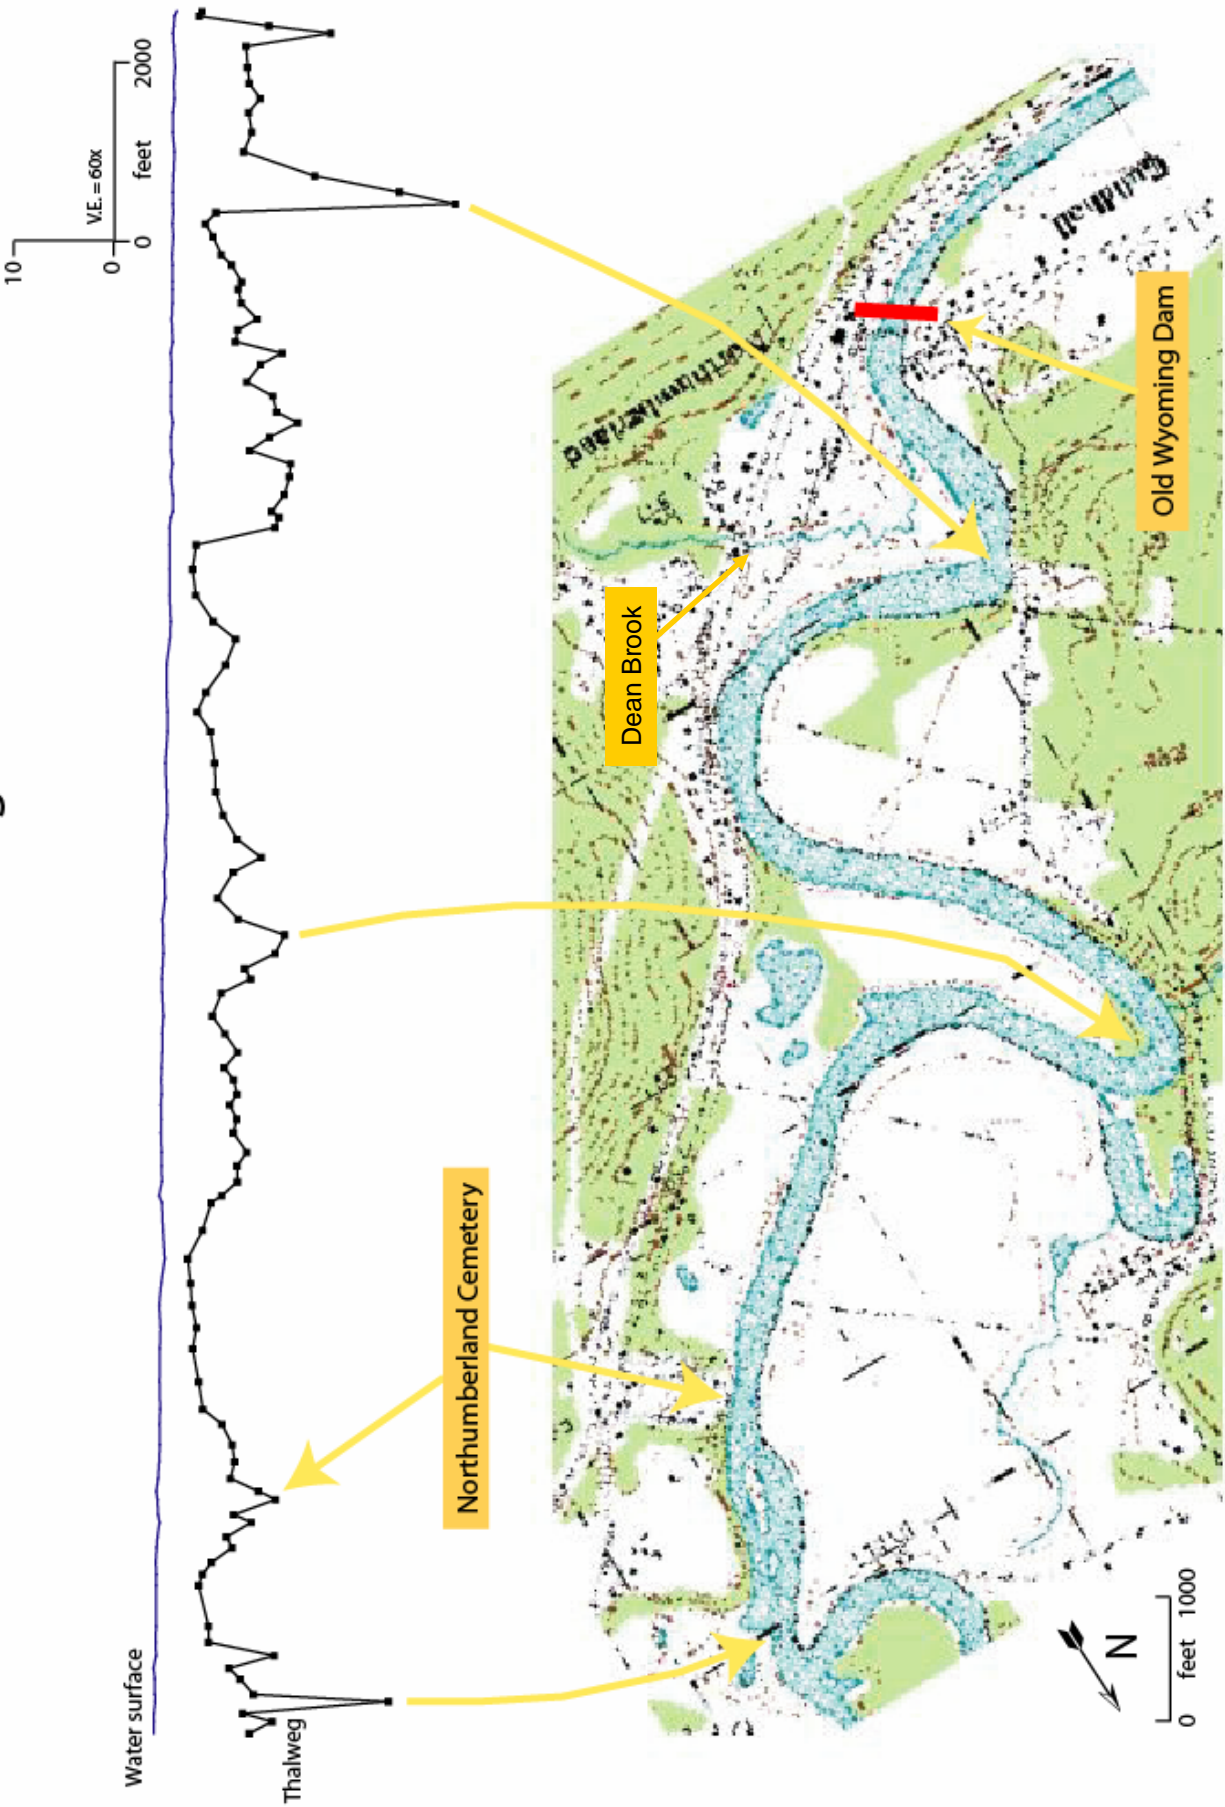
Bank Stabilization Implementation and Assessment – Figure 11

The most striking result of the longitudinal profile survey is the extreme depth of the channel bottom (27 feet deep) at the apex of the meander bend just upstream of the bridge between Guildhall and Northumberland (Figure 11). This point is located where the floodplain becomes constricted by 80 percent (compared with immediately upstream) between glacial uplands to the west and alluvial fan deposits from Dean Brook to the east. This constriction increases flow velocities sufficiently during large floods to scour the channel bottom to the great depths observed. This location is also coincident with large scale bank failures that have washed out the eastern half of Vermont Route 102.

The channel is also deep just downstream of the confluence of the Upper Ammonoosuc River where the floodplain is also slightly constricted between glacial uplands, although not as severely as further downstream (Figure 11). The deep pool near the confluence is also coincident with the new outfall pipe for the paper mill in Groveton, which is armored with metal sheet piling. Whether the channel has become deep as a result of encountering the sheet piling is unclear.

The channel elsewhere on the longitudinal profile is generally deeper at the apices of meander bends as is expected due to higher flow velocities on the outside bends of the channel and as the channel encounters the higher banks of glacial outwash deposits along the valley margins (Figure 11). The channel is shallowest and has its most uniform depth along the straightened portion of the channel downstream of the Northumberland Cemetery; this is consistent with the findings from other straightened channel segments studied during the 2004 fluvial geomorphology assessment (Field, 2004). The depth of the channel at the cemetery, located just downstream of a mid-channel sand bar, is deeper than elsewhere along the straightened segment but not as deep as in the meander bends.

two extremes immediately adjacent to each other (Cross Sections 7 and 10) where the channel is extremely deep in the meander bend upstream of the bridge (Figure 11 and Appendix 5). The low width:depth ratio occurs at the deep pool with the high width:depth ratio found immediately upstream where the channel is shallow and wide as a result of sediment being deposited in the backwater area behind the constriction. A high width:depth ratio (43.0) also occurs at Cross Section 2 where a large point bar has developed in the meander bend immediately downstream of the long straightened segment. Increased sediment transport capacity through the straightened segment results in increased deposition in the meander downstream where sediment transport capacity is reduced. Width:depth ratios for the remaining cross sections are within expected ranges, suggesting the channel is not undergoing significant adjustments at these locations.

Connecticut River Longitudinal Profile

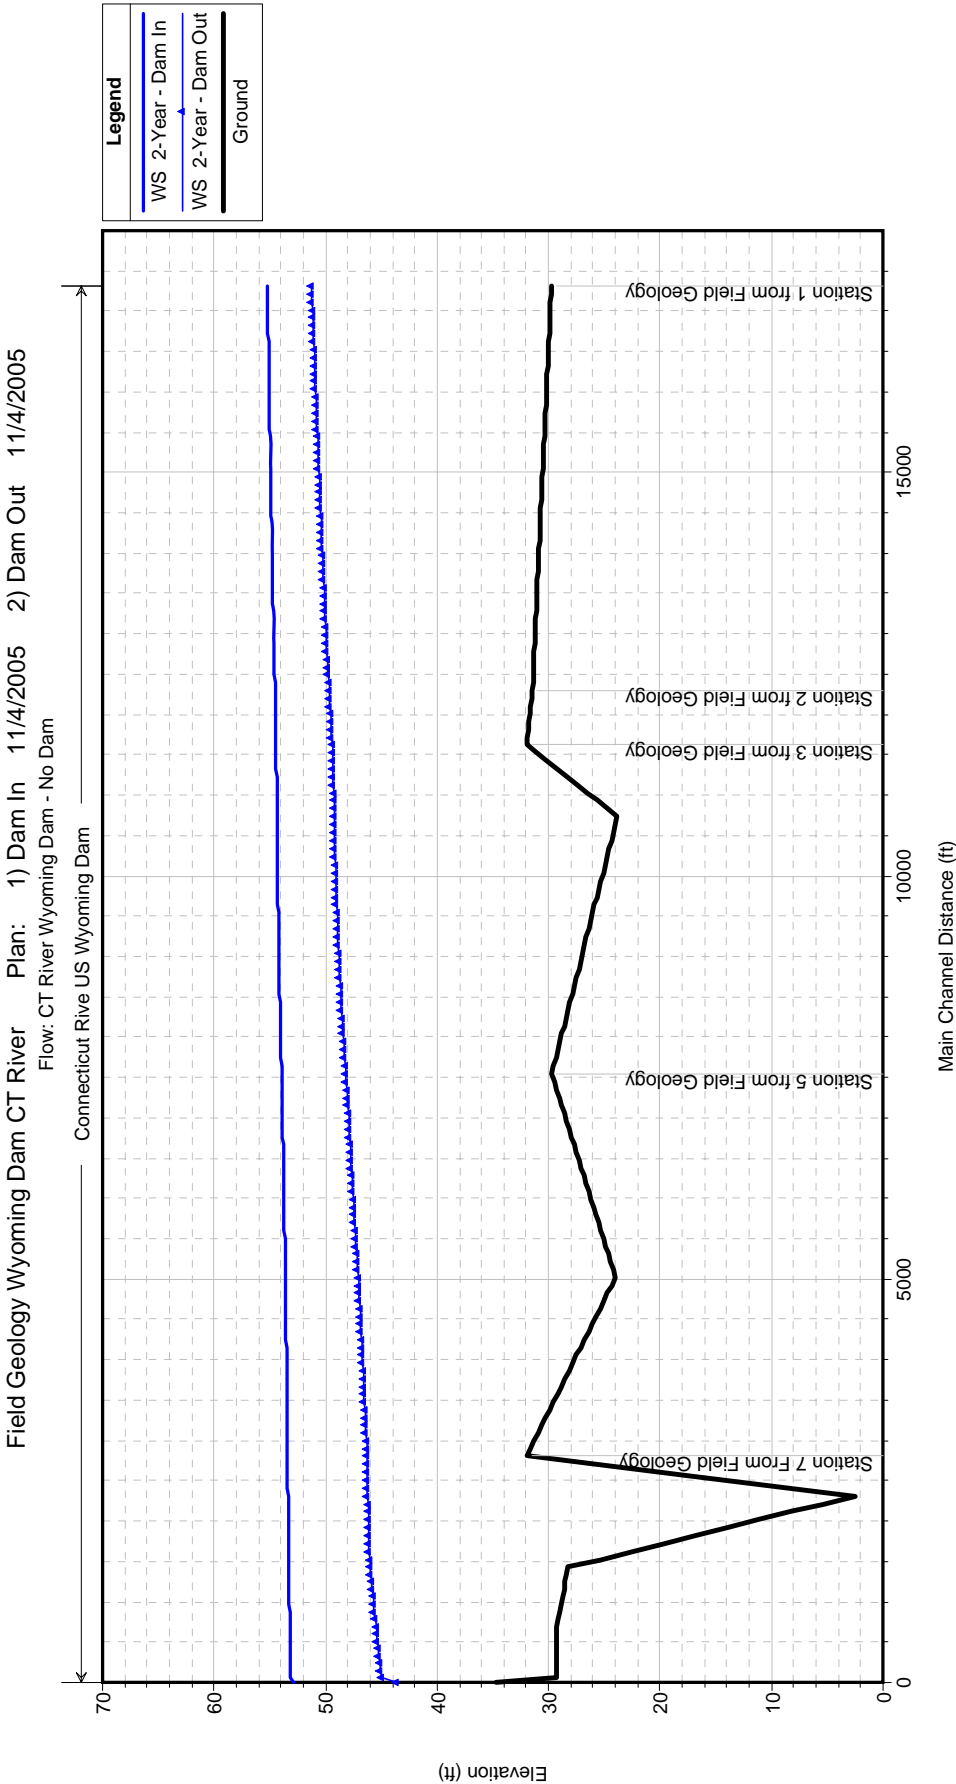
Computed Water Surface Profile for 2-Year Event

Note: Old Wyoming Dam at left margin of graph. Station numbers are same as cross sections shown in Figure 8 with Station 1 at Northumberland Cemetery.

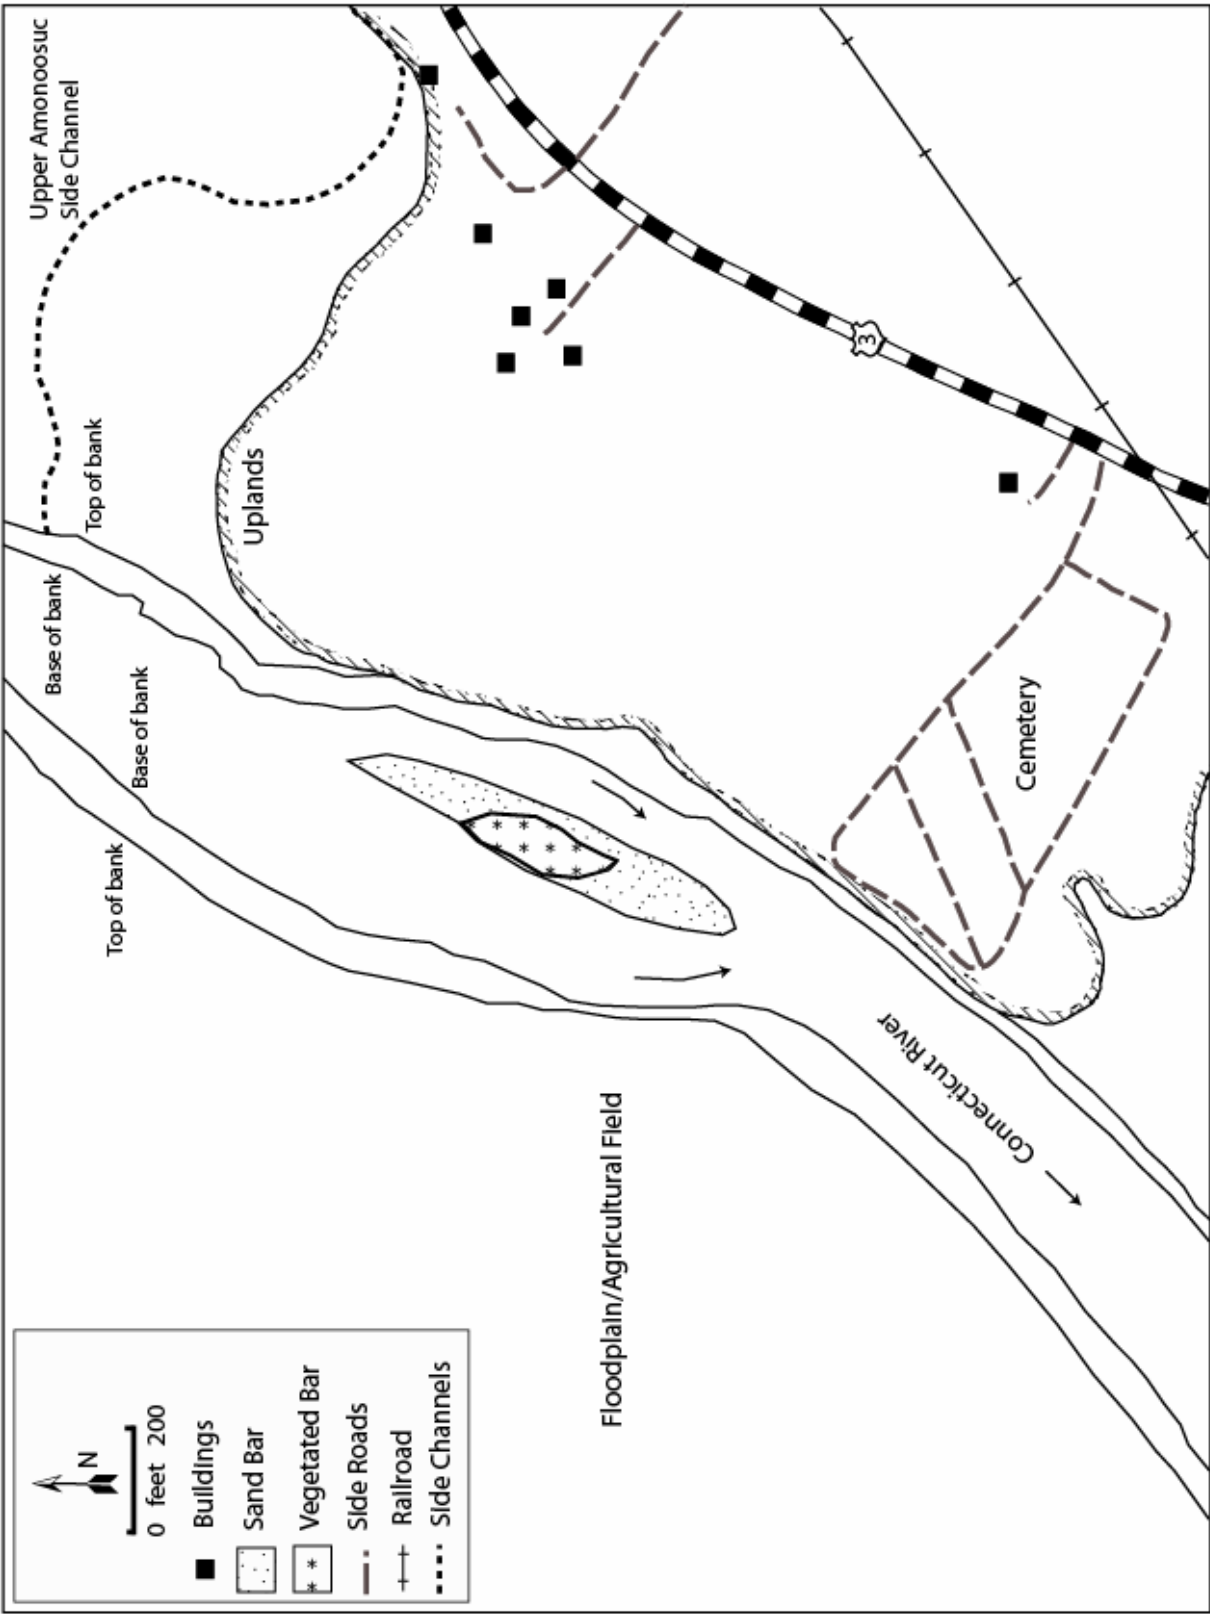
Bank Stabilization Implementation and Assessment - Figure 16

Northumberland Cemetery - Close-up
